TECHNICAL BULLETIN

CORROSION RESISTANCE TESTING ON HOG FLOORING: J&L vs. the Competition

SALT-SPRAY EXPOSURE TEST – ASTM B117 Salt Spray (Fog) Exposure

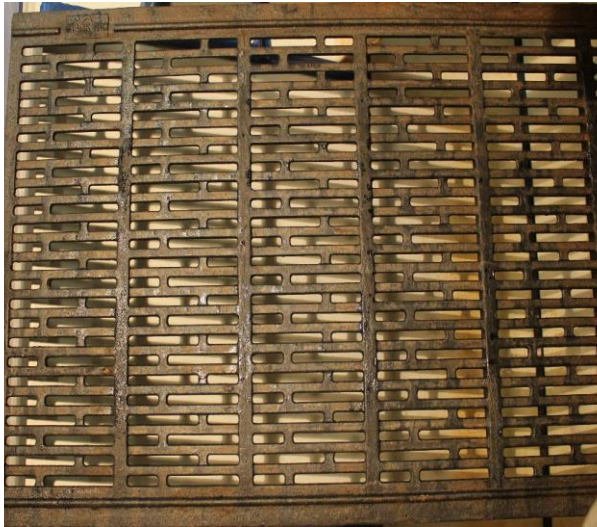
COMPETITOR #1
Cast Iron Floor Panel
After 6 hours

As expected, due to the lack of a protective coating, red rust immediately began to form after exposure to salt-spray. After only 48 hours, extensive deterioration of the steel was evident. It was decided to continue with testing to observe the corrosive effect and for comparison to the other samples.

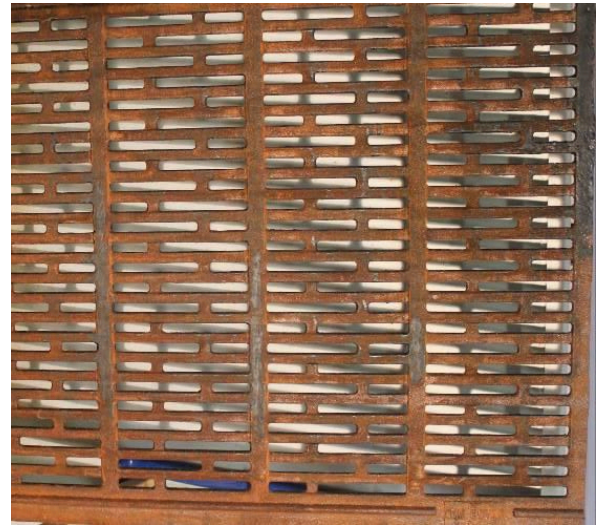
COMPETITOR #1
Cast Iron Floor Panel
After 48 hours

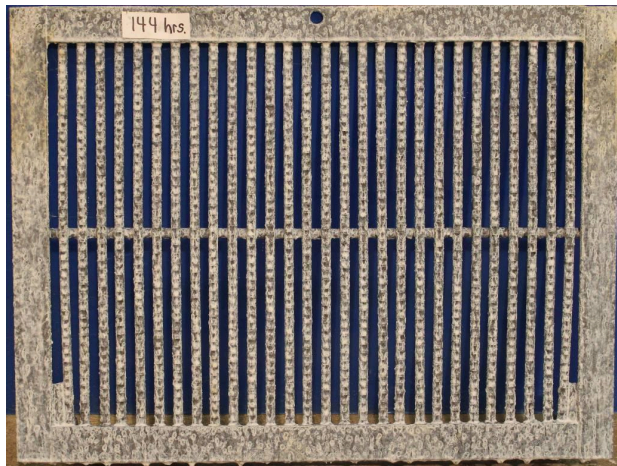
COMPETITOR #2
Triangular Floor Panel
After 144 hours

The photographs above reveal the surface condition of the triangular bar floor panel after 144 hours of exposure. As can be seen, the panels are holding up well to the corrosive environment revealing only slight signs of deterioration. The photograph to the right was enlarged to point out the slight yellowing in the upper left corner of the panel, and to show the deterioration of the coating along the outer portions of the ridges found along the surface, but no visible signs of red rust are evident.

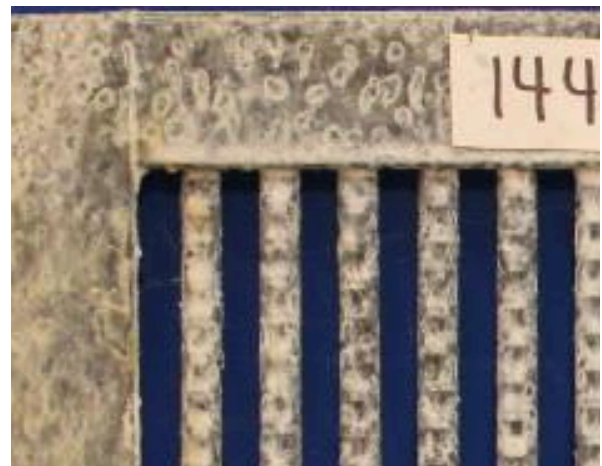
COMPETITOR #2
Triangular Floor Panel
After 144 hours
(Enlarged to show beginning yellowing)

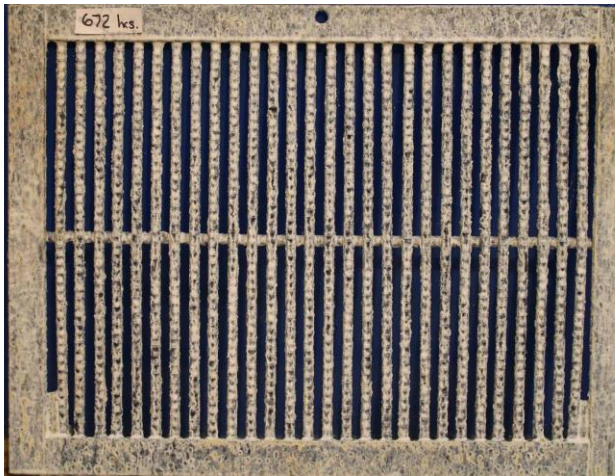
COMPETITOR #2
Triangular Floor Panel
After 672 hours

As seen from the photographs taken after 672 hours of salt-spray exposure, the triangular bar panels reveal the beginning of red rust. As with the other panels tested, in time the deterioration process would continue causing metal fatigue and eventual failure. Worth noting, our primary point of focus was on the outer-flat portions of the panel, which held up well during testing as seen in the photographs. Of interest, was the apparent loss of protection on the edges of the ridges found on the cross bars during the early part of testing. On these edges, the protective coating does not appear to be as effective.

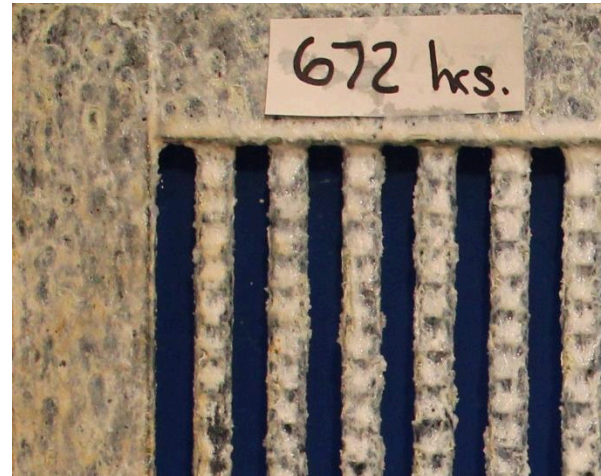
COMPETITOR #2
Triangular Floor Panel
After 672 hours
(Enlarged to show formation of red rust)

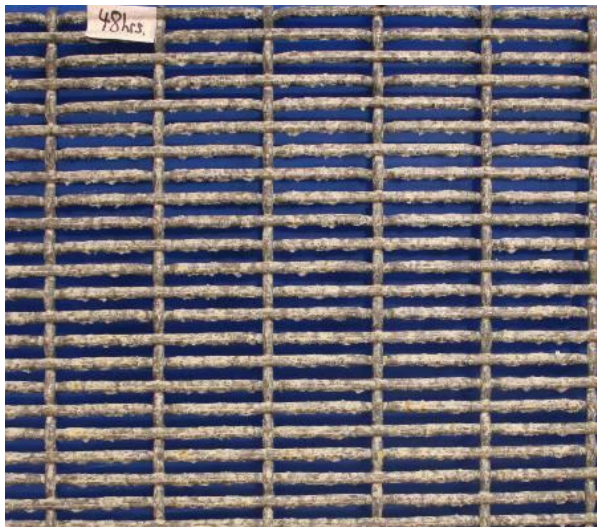
J&L
Standard Floor Panel
After 48 hours

Testing after 48 hours on the J&L panel revealed the beginning of red rust due to the deterioration of the zinc coating. The oxidation of the zinc coating is still protecting portions of the panels, but not to the extent to prevent rest rust from forming. Although better than the cast pieces from Competitor #1 (covered with a fine coating of red rust), it was falling short with Competitor's #2 panel. Early testing confirmed that our standard floor needed to be better. Coupled with past history and comments from our customers, J&L had invested resources to research alternative methods that would improve our coating process. The result was an improved (upgraded) version of our standard floor that was added for testing.

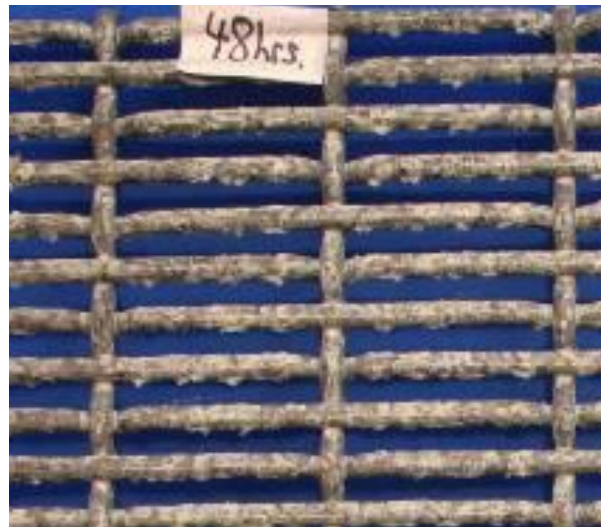
J&L
Standard Floor Panel
After 48 hours
(Enlarged to Show Deterioration of Coating)

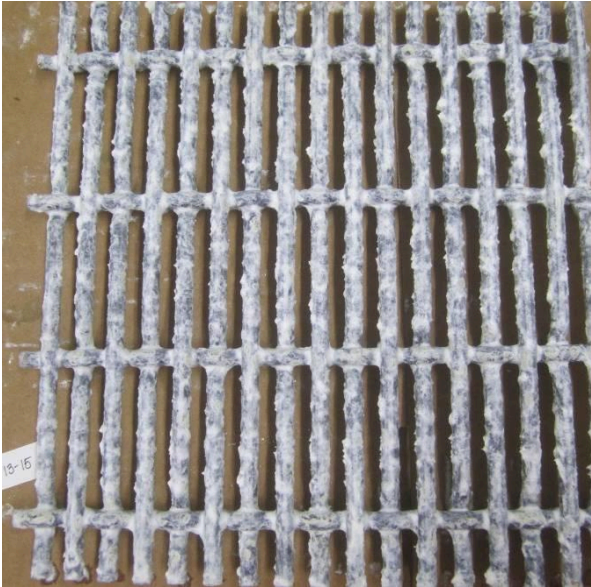
J&L BOSS HOG EXTRA™
Improved Floor Panel
After 552 hours

The photograph taken on J&L's Boss Hog Extra™ improved floor panel after 552 hours was to show how the protective zinc coats the metal to protect the base metal from oxidation. In the enlarged photograph, you can see the powdery coating formed from the oxidation of the zinc. This powdery coating that forms over the steel wire is protecting it from the deteriorating effect of red rust corrosion (iron oxide – Fe_2O_3). After 552 hours of salt-spray exposure, the panel is holding up well with only minimal signs of the corrosion process.

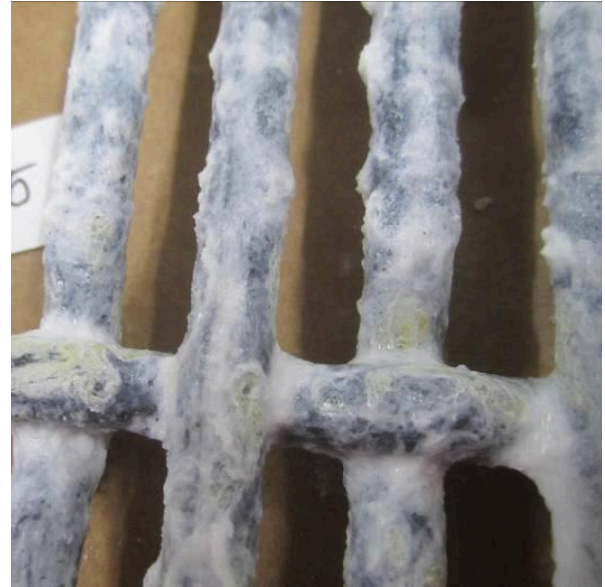
J&L BOSS HOG EXTRA™
Improved Floor Panel
After 552 hours
(Enlarged to show protective coating)

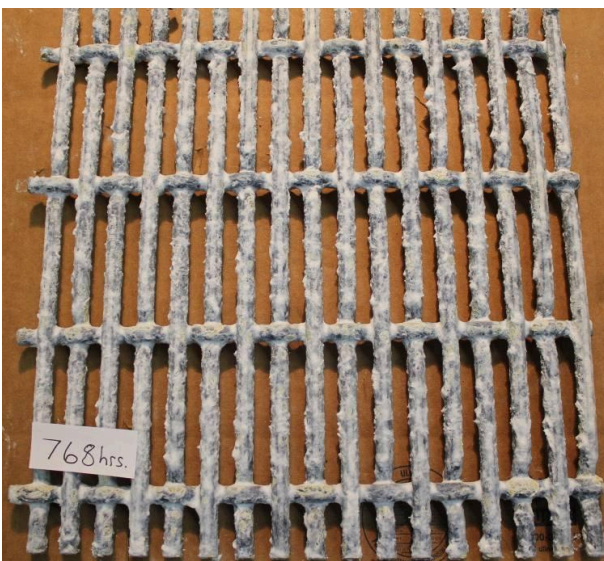
J&L BOSS HOG EXTRA™
Improved Floor Panel
After 768 hours

The photograph taken at 768 hours was at the completion of testing. As can be seen from the photograph, the panel is intact with minimal signs of corrosion. Viewing the enlarged photograph, again you can see the protection afforded to the steel wire from the zinc oxide that has formed. Again, only minimal signs of the corrosion process are present.

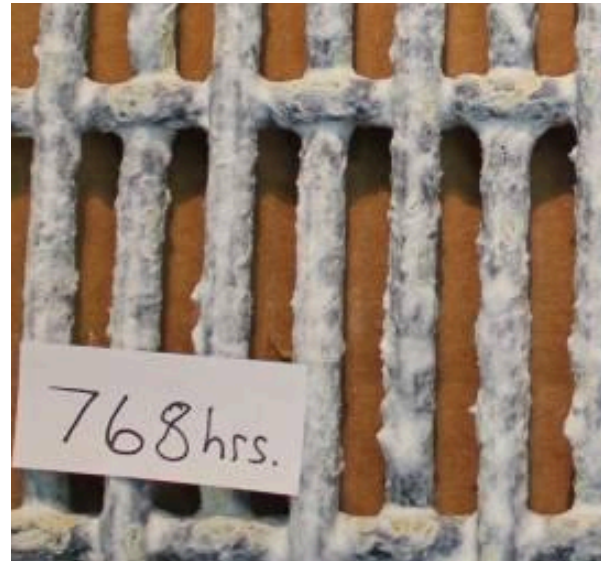
J&L BOSS HOG EXTRA™
Improved Floor Panel
After 768 hours
(Enlarged to show protective coating)

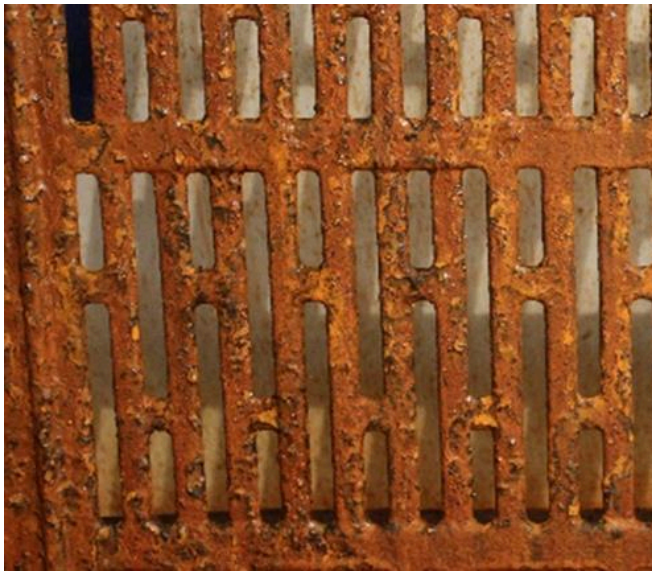
COMPETITOR #1
750 Hours Exposure
Extreme Corrosion of Base Metal

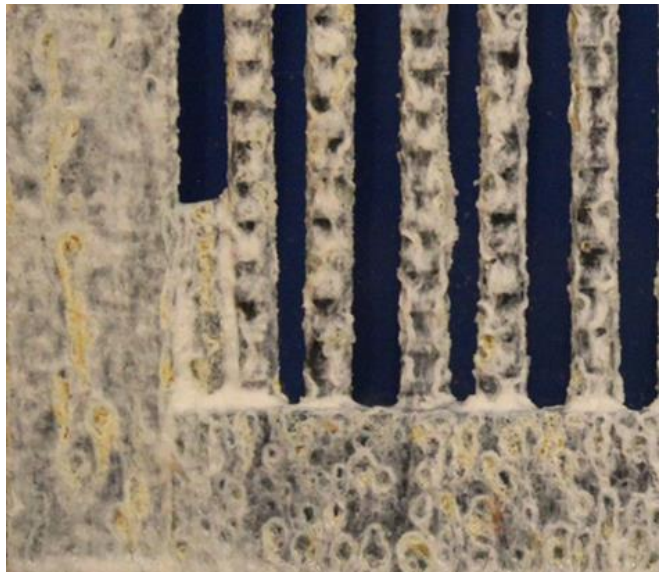
COMPETITOR #2
750 Hours Exposure
Some Corrosion (red rust)
Powdery Oxide Seen from Protective Coating

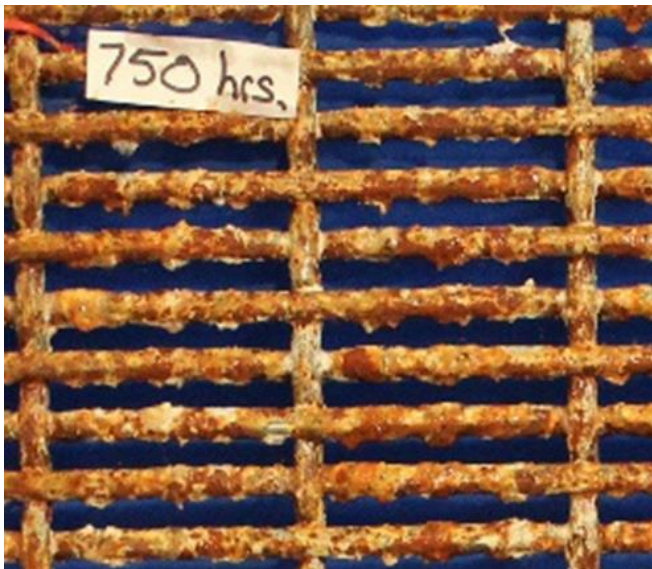
J&L STANDARD FLOOR
750 Hours Exposure
Extensive Corrosion (red rust)

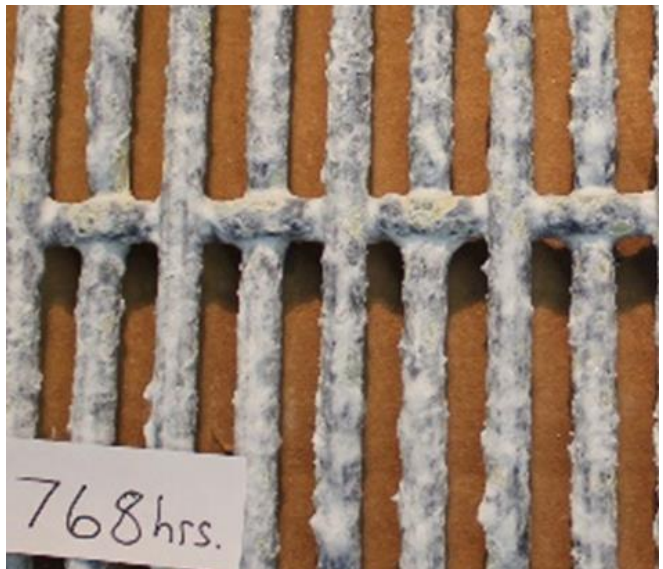
J&L IMPROVED FLOOR PANEL
(BOSS HOG EXTRA™)
768 Hours Exposure
Signs of Yellowing
Powdery Oxide Seen from Protective Coating
